At your request I have tested the Yeti provided by Wippells to compare its behaviour to our Yeti.

The purpose of the trial was to demonstrate that there is “nothing wrong with our vehicle” as “all DSG equipped vehicles behave the same”.

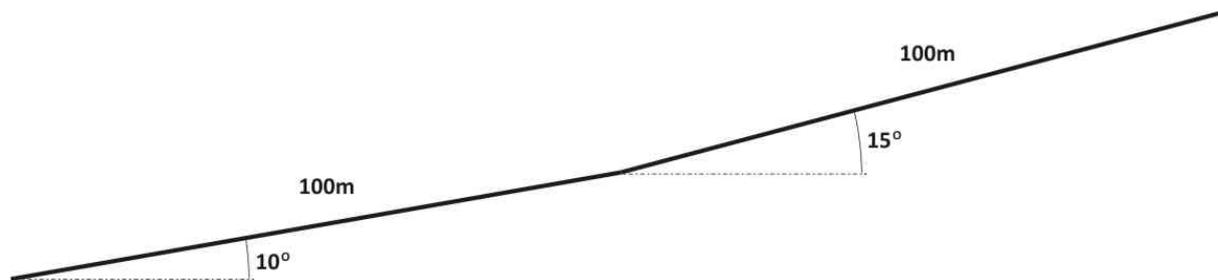
Murphey Street gradients

5 trips up Murphy Street Ipswich (initial slope approximately 100m long at 10° with a second slope approximately 100m long at 15°) @ approximately 10km/h with D1 indicated on the instrument panel.

Approximately 20m from the top of Murphey Street on the 5th lap there was a “hot clutch” smell and gearbox overheat warning appeared on the maxidot display. The clutch disengaged and the vehicle began to roll backwards unchecked down the slope. The vehicle was brought to a halt using the brake and driven away normally after the gearbox overheat warning had extinguished.

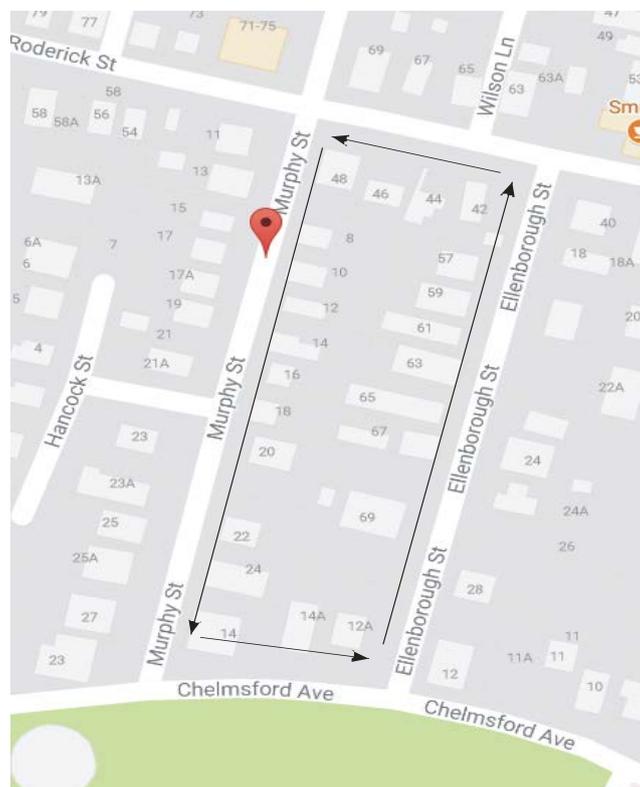
The test was conducted continuously with the vehicle being driven in up Murphy Street with a left hand turn at the top into Chelmsford Avenue, another left hand turn into Ellenborough Street, another left hand turn into Roderick Street and then a final left hand turn back into Murphy Street. Driving from the top of Murphy Street around the block to the bottom of Murphy Street was conducted at normal road speed.

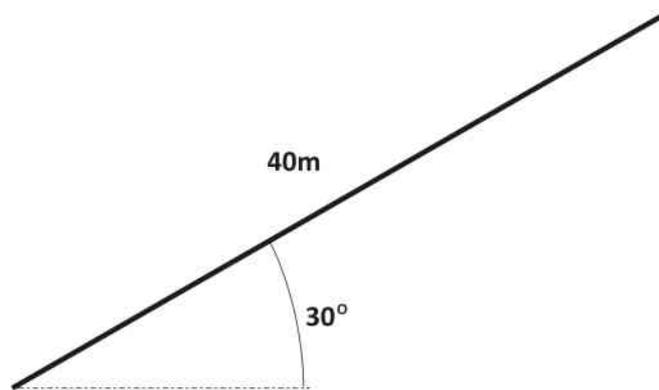
Riverlink Centre Exit gradient

10 trips up the underground car park centre exit (40m long at a slope of approximately 30°) of Riverlink Shopping Centre Ipswich @ approximately 3 - 8km/h with D1 indicated on the instrument panel. This testing was continuous with a U turn being performed shortly after the top of the exit before travelling back down into the car park at normal driving speed. This slope was selected as our vehicle has experienced several warning level 1 clutch disengagements here.

During this testing there was no level 1 or level 2 clutch disengagement, no hot clutch smell or gearbox overheat warning.
