### Loss of drive through a right hand turn

This first problem has been happening from new (brought to the attention of Wippells when the Yeti went in on it's first (15000km) service). In this problem the Yeti randomly loses power when trying to accelerate quickly out of a right hand turn after a period of time at speed on cruise control. To clarify what is happening when this occurs I have included a diagram of where the loss of drive most frequently occurs (because I drive through this intersection most often) along with a table comparing the Yeti's operation both normally and when the loss of drive occurs.

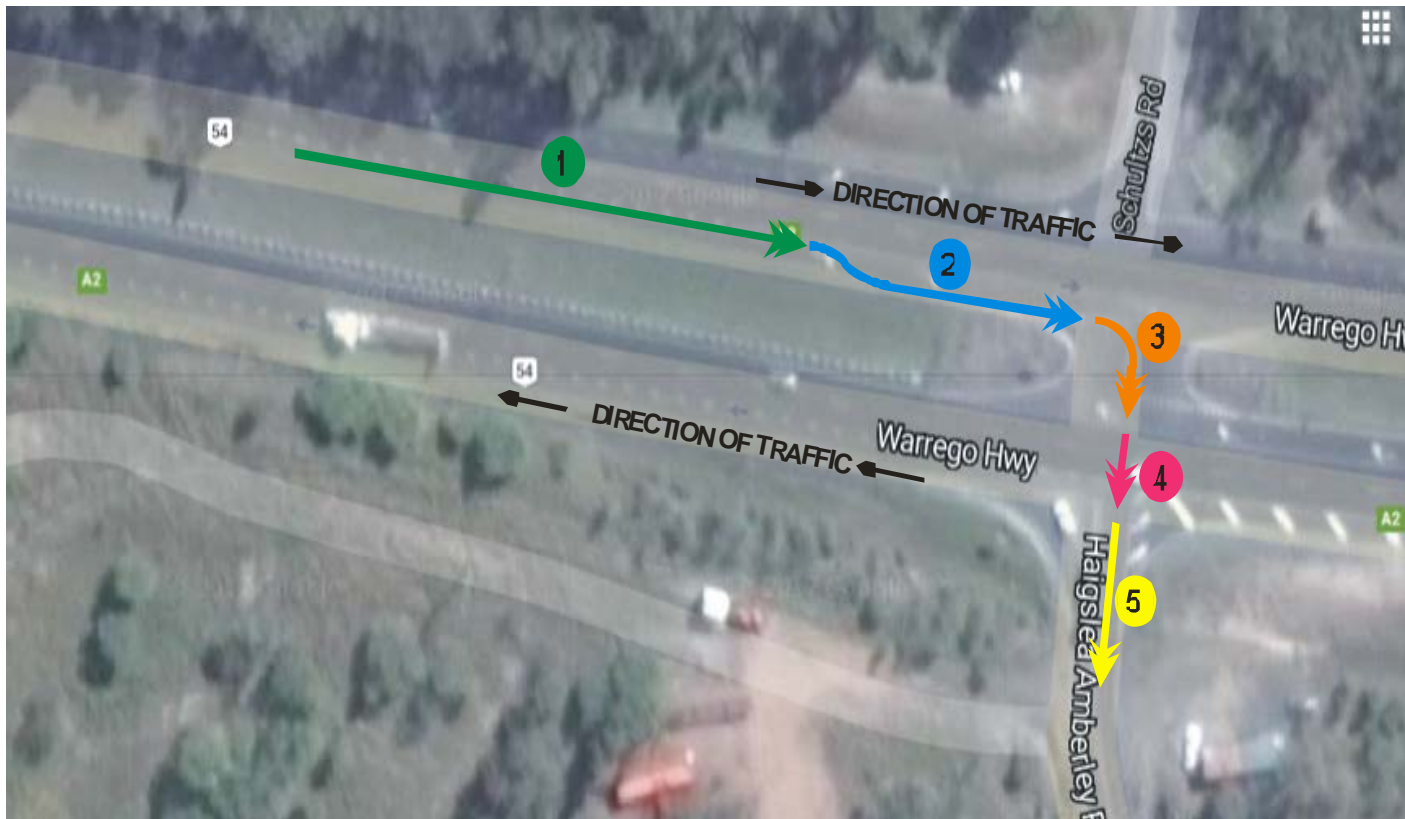
Stage	Normal Operation	Loss of Drive Scenario
1 (green)	Travelling along at 100km/h with cruise control <b>ON</b>	Travelling along at 100km/h with cruise control <b>ON</b>
2 (blue)	Foot on brake pedal for a rapid deceleration to prepare to enter the crossover between the lanes on the highway.	Foot on brake pedal for a rapid deceleration to prepare to enter the crossover between the lanes on the highway.
3 (orange)	Foot still on brake into and through a right hand turn with Yeti still slowly rolling at approximately 10 - 15 km/h.	Foot still on brake into and through a right hand turn with Yeti still slowly rolling at approximately 10 - 15 km/h.
4 (magenta)	Press the accelerator quickly to the floor for a break in the traffic. After an extremely brief pause (turbo lag) the Yeti quickly accelerates across the highway. A corresponding rapid increase in RPM and normal gear change indications are displayed on the instrument panel.	Press the accelerator quickly to the floor for a break in the traffic, the Yeti continues to roll across the road without accelerating. D2 and around 1200rpm are indicated on the instrument panel.

5 (yellow)	Yeti continues to drive normally.	After several seconds the Yeti quickly accelerates with a corresponding rapid increase in RPM and normal gear change indications displayed on the instrument panel. The Yeti behaves normally thereafter.
